# The Uniform Building Inspection Report™

14841 N. Black Canyon Highway, Phoenix, AZ 85023

Norte Academy

110411A

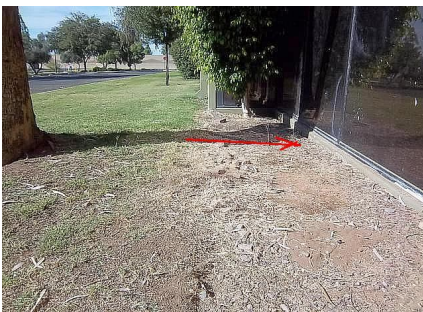
Photo: 0060 (1)

[R] 0060: Drainage near building questionable at some areas at East and South sides of building with ponding potential and evidence at these areas. Advise adjusting grading for better drainage. (some stains noted at floor areas at South interior walls from possible ground water)

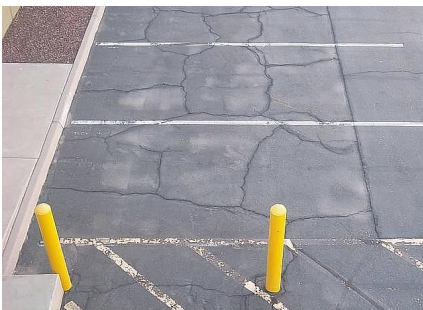
Photo: 0210 (1)

[P] 0210: Common and typical wear noted at asphalt at parking and driveway areas. Past crack repairs noted. Advise minor repairs and coating of surfaces to extend life span.

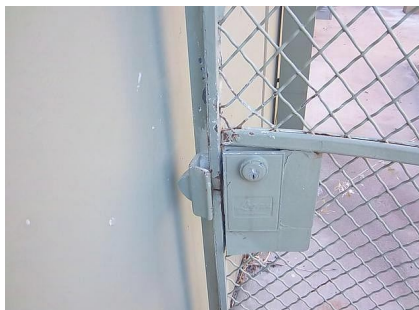
Photo: 0610 (1)

[R] 0610: Metal gate not properly latching or locking at North mechanical yard. Gate latch is also damage at East side of east patio area.  
See series 0610 photo(s)

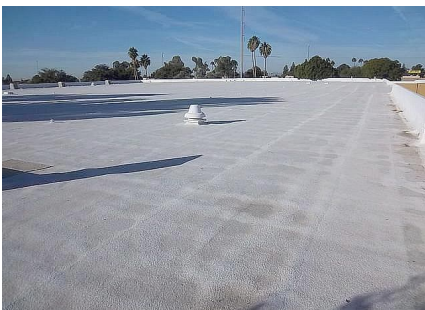
Photo: 1000 (1)

[R] 1000: Roof material is Urethane Foam and approx. 6 years old (per documentation) Several past repairs were noted. Additional repairs needed and detailed below including material separating at some edge flashings at parapets and several blisters and delamination noted. Further investigation and possible repair is advised at all scupper drains (stains at several interior areas along South wall) Advise complete review with cost to cure and life expectancy of material.

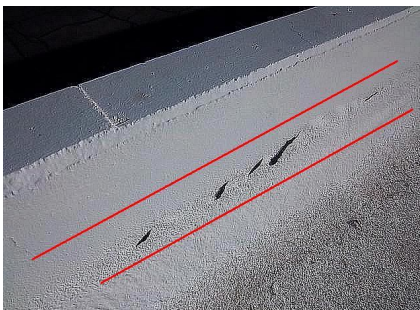
Photo: 1001 (1)

[R] 1001: Foam roof material cracked and separating at roof parapets. Noted at several areas at front (West) half of roof. Advise review and repair of these flashings at all parapet walls after debris has been removed.

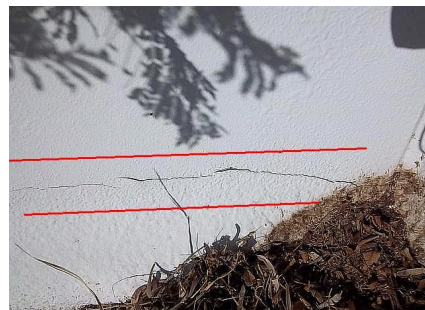
Photo: 1010 (1)

[R] 1010: Roof material cracked at front roof parapet.

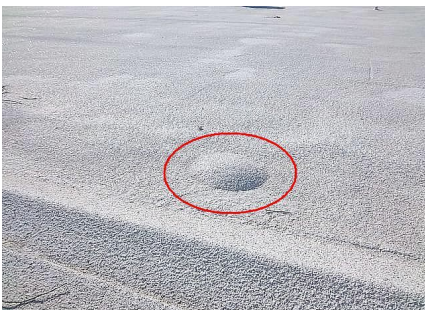
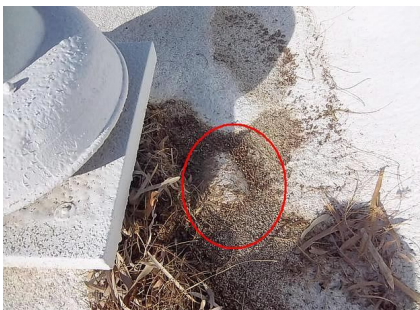
[R] 1020: Several blisters noted at foam roof material including North side and East sides of roof and center roof.  
See series 1020 photo(s)

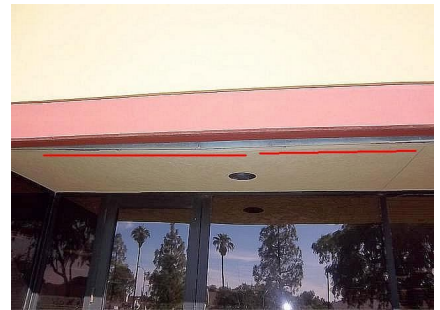
Photo: 1310.05 (1)

[R] 1310.05: Some sagging noted at exterior ceiling board at center wall inset at South side. Additional anchoring may be needed.

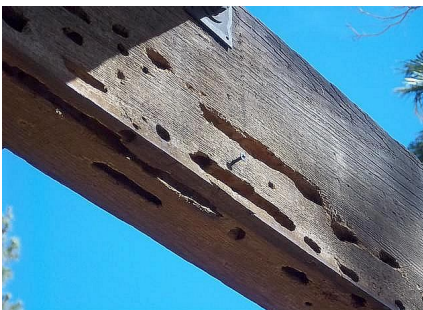
Photo: 1430.20 (1)

[R] 1430.20: Some small areas of wood damage from dry rot noted at East patio wood latia with some additional insect damage noted at these wood posts.

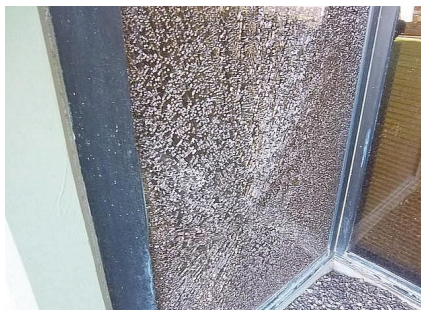
Photo: 1500.02 (1)

[R] 1500.02: Glass damaged at 5 windows including small pane at North side. (North side, 1 damaged at West, 2 boarded up at South, East patio) Glass has some scratching at some additional areas.

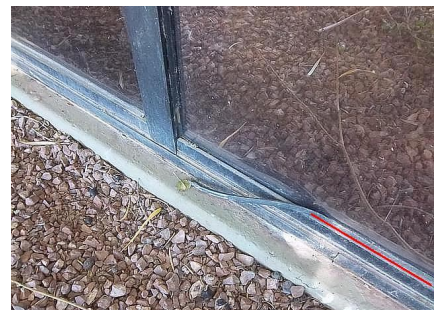
Photo: 1530 (1)

[P] 1530: Rubber trims loose and gapped at several windows at exterior. Advise review and repair.

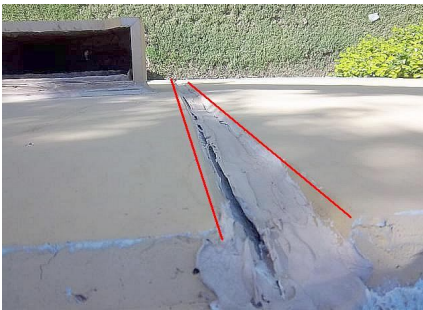
Photo: 1910 (1)

[R] 1910: Caulking, sealing of gaps advised at seams at exterior walls sections around perimeter of building. Some past repairs noted and some stains noted at recessed ceiling areas at these seams.

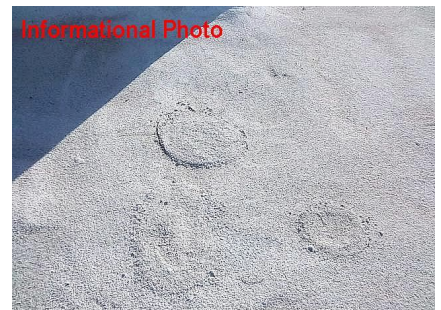
Photo: 1950 (1)

[Note] 1950: View of past repairs at roof.

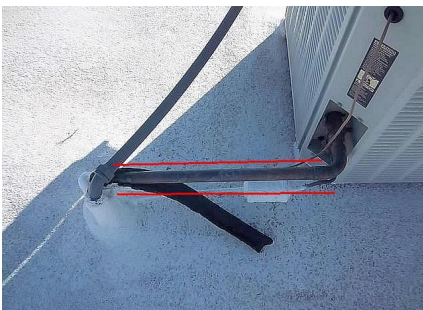
Photo: 2300.01 (1)

[R] [E] 2300.01: Refrigerant line insulation damaged/missing at some areas at 4 Trane a/c units at center roof.

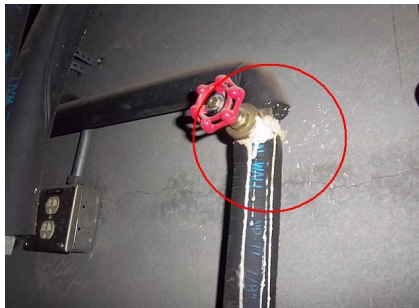
Photo: 4180.01 (1)

[N] [M] 4180.01: Pipes / fittings atop water heaters corroded.

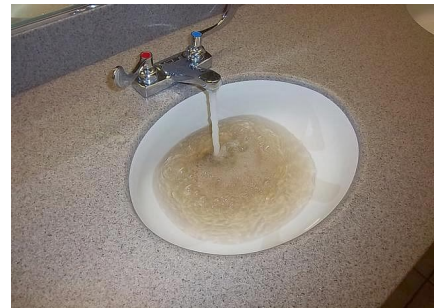
Photo: 4490.01 (1)

[R] 4490.01: Water discoloration noted on hot sides of faucets at all restrooms. Advise further investigation including water heaters.

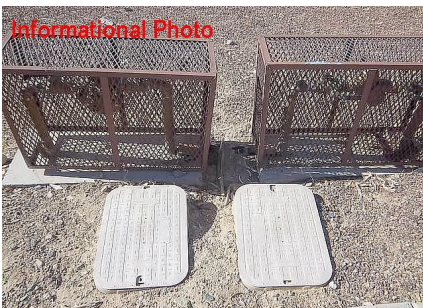
Photo: 4540.01 (1)

[Note] 4540.01: 3 Main water meters observed (2 at East yard, 1 at South yard). 1 is likely for interior water use with others likely for irrigation.

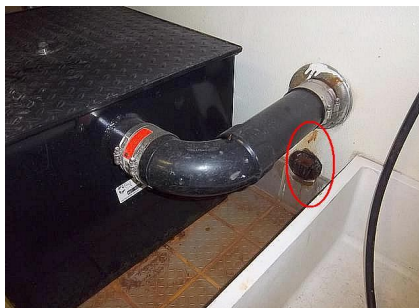
Photo: 4600.11 (1)

[R] 4600.11: Fixture drain line leaks at wall near grease interceptor at kitchen. Advise review and repair of this leak along with interceptor.

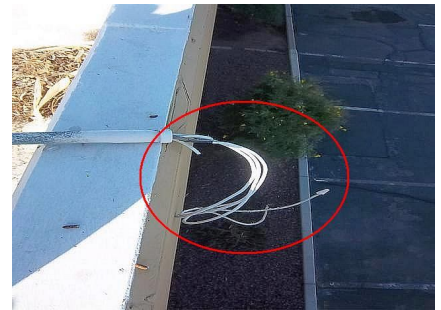
Photo: 5360.01 (1)

[R] 5360.01: Wiring is energized and loose at NW roof parapet area. Apparently for past signage. Review and repair.

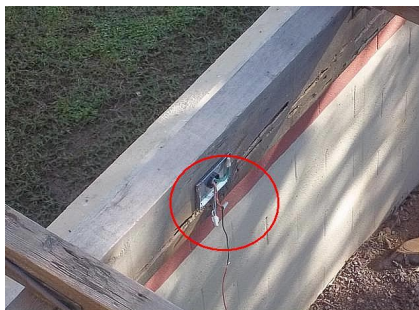
Photo: 5650.20 (1)

[R] 5650.20: Light fixture missing with loose energized wiring exposed. Several patio lights were not operational during testing with some lenses missing. Noted at rear patio.

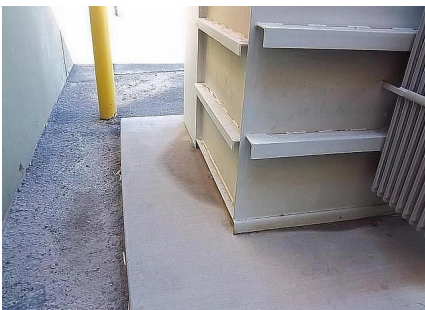
Photo: 5912 (1)

[N] 5912: Some oil leaking noted at electric transformer near North mechanical eq. yard.

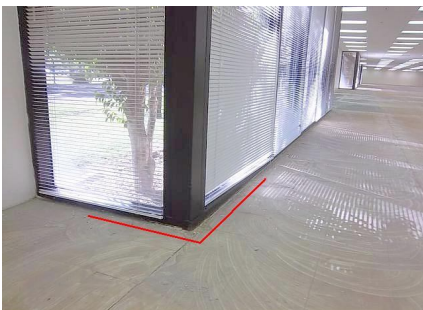
Photo: 7000.01 (1)

[N] 7000.01: Stain noted on interior many areas

along exterior wall. Some stains are at exterior doors, some stains along South side may be from improper grading at exterior. Some stains may also be from caulking gapped at seams between concrete panels.

[N] 7000.01: Stain noted on interior surface at wall inset areas at South side.

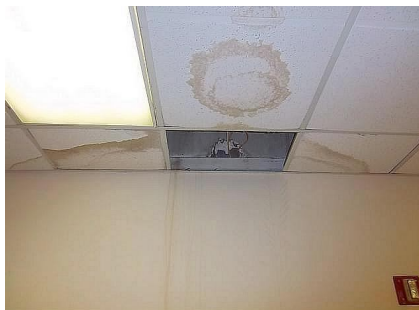
Photo: 7010 (1)

[N] 7010: Water intrusion evidence with some water damage noted at two areas along South interior wall (roof drain scuppers at these areas) Advise further review of these and all roof scupper drains. Other various stains noted at ceiling tiles likely from past roof leaks.

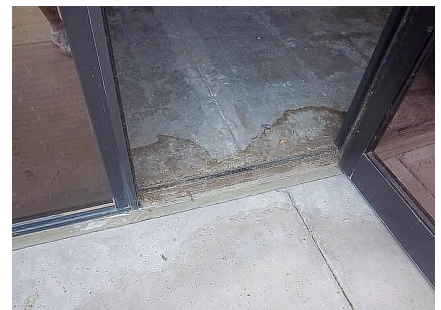
Photo: 7450 (1)

[P] 7450: Weather-strip missing/gapped at exterior doors with some stains inside threshold at these areas. Noted at: 1) Large East entry, 2) Center North exterior door. Review all exterior door weather-stripping.

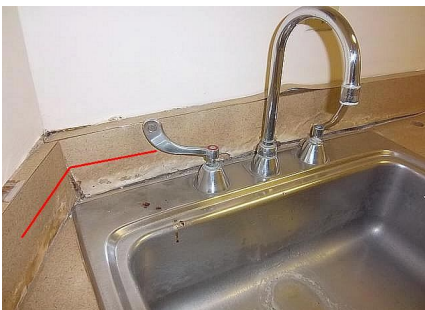
Photo: 8810.02 (1)

[R] 8810.02: Countertop backsplash damaged at sink at side of rear dining area.

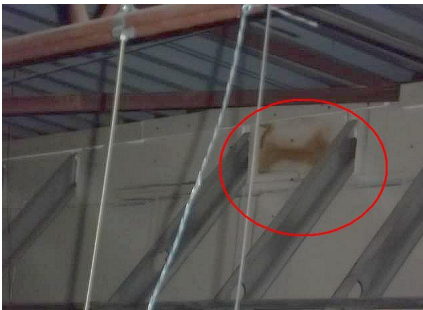
Photo: 9650 (1)

[R] 9650: Roof leak evidence noted with stains on building materials noted below parapet walls at front edges of roof (flashings separated at these areas)

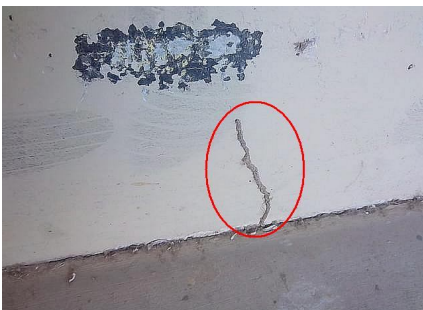
Photo: 9850.01 (1)

[R] 9850.01: Evidence of termites noted at various areas including several areas at slab floor, exterior at loading dock, inside cabinet below soda machine at kitchen area, near kitchen electrical sub panel. Advise further review and treatment.

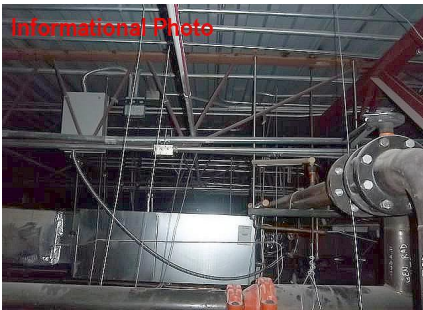
Photo: 9903 (1)

[Note] 9903: General view ceiling areas.
