SEWER SCAN REPORT

PROPERTY ADDRESS: 1848 E. Whitton Ave

DATE AND TIME OF SCAN: July 23, 2020 at 2pm

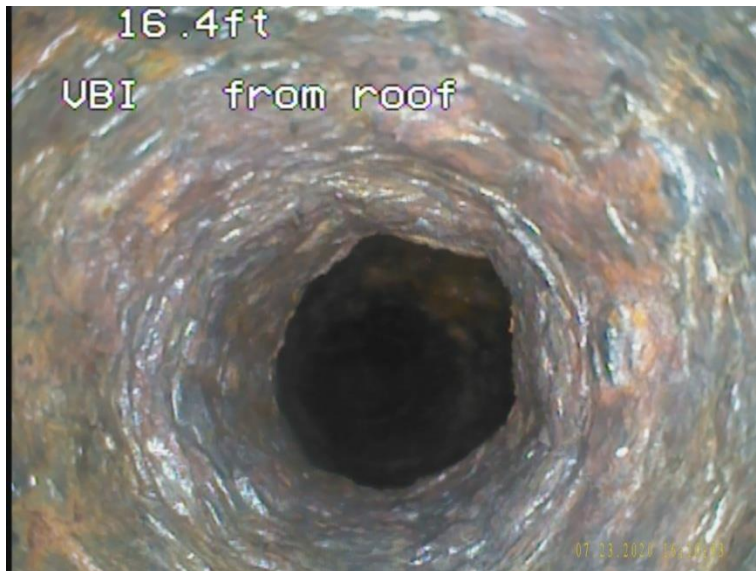
MAIN SEWER LINE/PIPE CONDITION: Considerable wear and common for age with cast iron piping below slab and concrete piping at yard. Cast iron rusted at areas. Concrete piping has some offsets and cracks noted. No loss of flow was observed to indicate noticeable leaking at piping but concrete and cast iron piping may

General view of rusting at cast iron piping

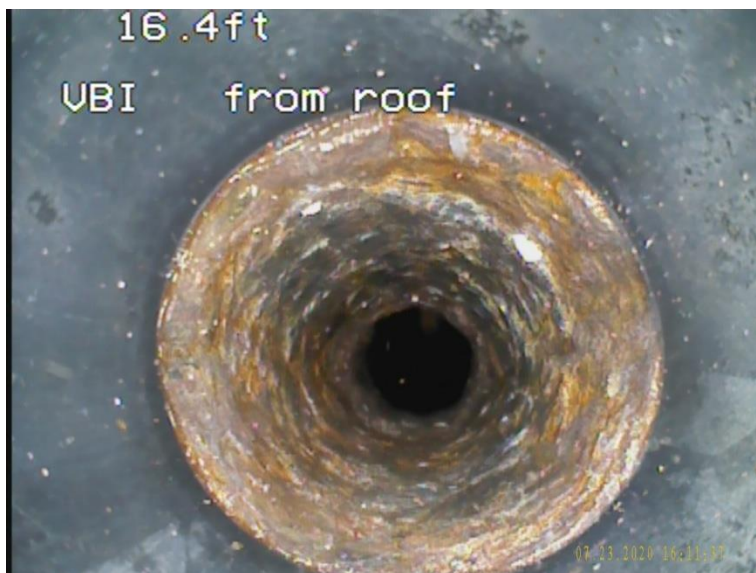
ABS to Cast Iron connection

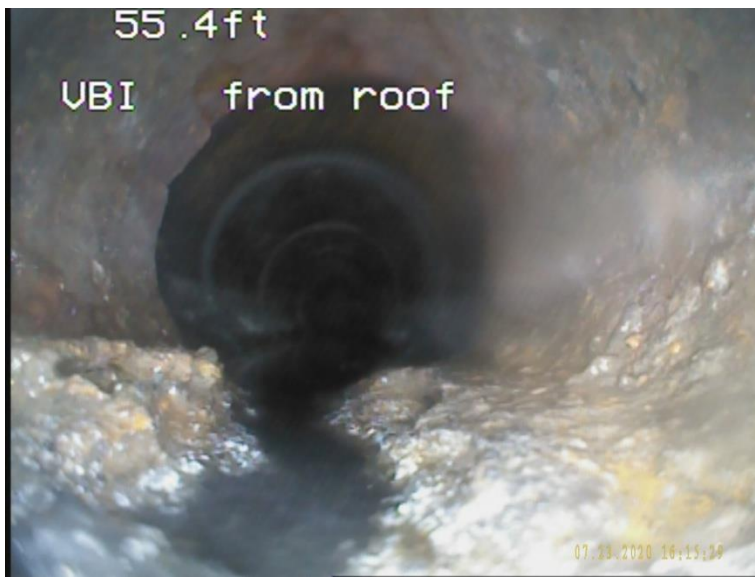
Debris at cast iron piping

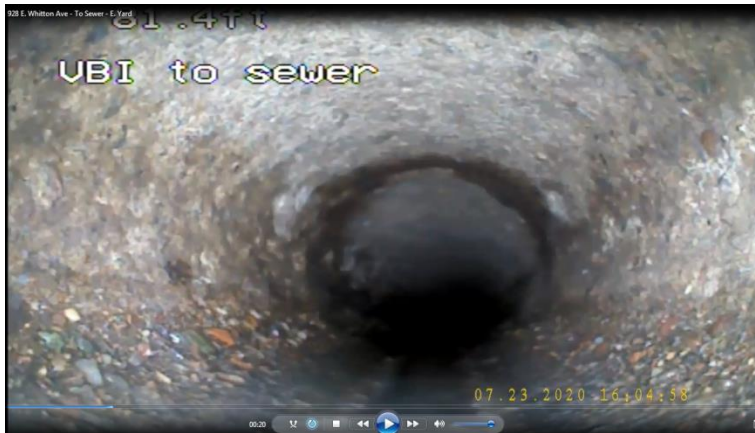
General view of concrete piping

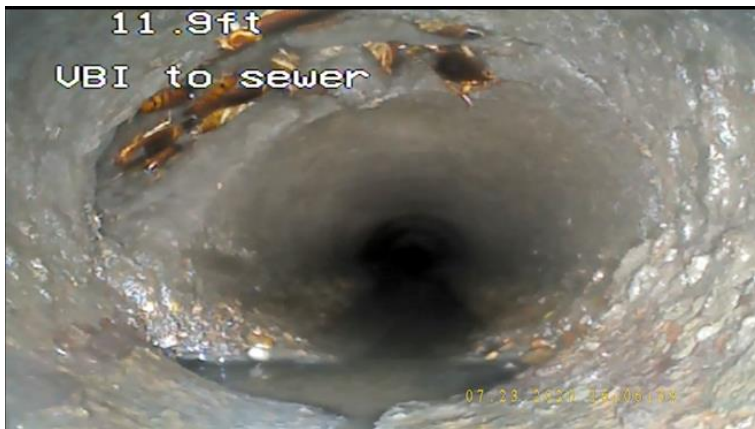
have a limited life span. Section of damaged/ or pipe offset with crack at base noted at 12' (8' lateral from c/o) Some bellying was noted of piping below home. Generally good flow observed.

Section of damage or pipe offset, crack at base, approx. 8' from E. Yard cleanout

MAIN SEWER LINE/PIPE RECOMMENDATIONS: We advise review by a plumbing contractor including condition of pipe materials and specifically assessment of damage/offset near E. yard cleanout.
