PROPERTY INSPECTION REPORT

Pre-Slab Inspection

Date of Inspection: 10/8/2021

Addr: 1832 N. 49th Drive, Lot #39

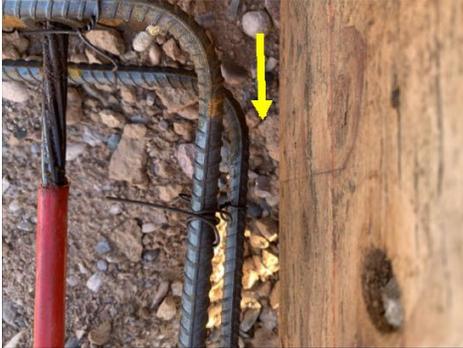
- Rebar out of position. Minimum standards require a min. of 2" of concrete around all areas of steel. Noted at both front corners of garage

Rebar out of position to maintain 2" of concrete around all areas. Noted at both front corners of garage

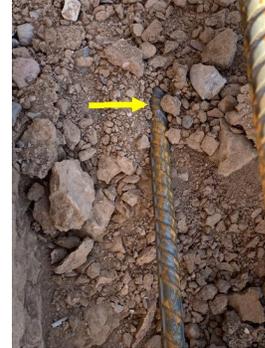
Rebar out of position to maintain 2" of concrete around all areas. Noted at both front corners of garage

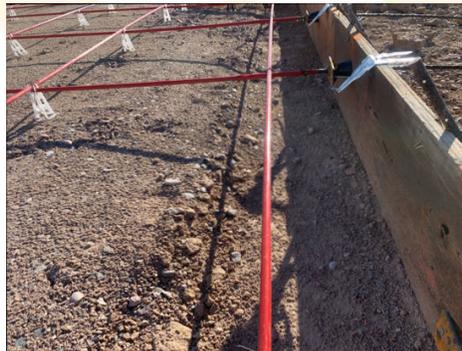
- Turn down footings are very shallow at rear of home. Advise review.
- Form not plumb at edge of rear patio. Advise adjustment.

Turn down footings are very shallow at rear of home. Advise review.

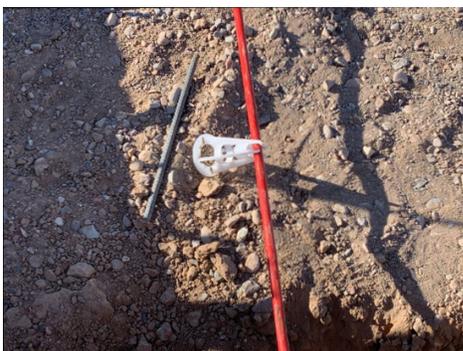
- Cable supports crooked at several areas

Cable supports crooked at several areas

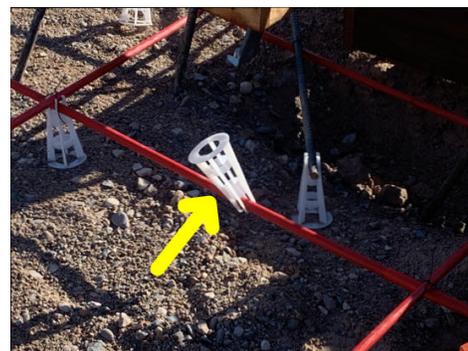
Cable support out of position at rear patio

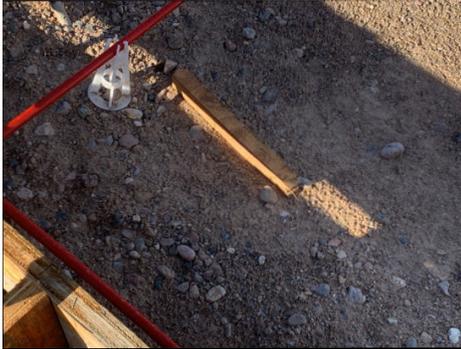
Clean all debris from area prior to pour.

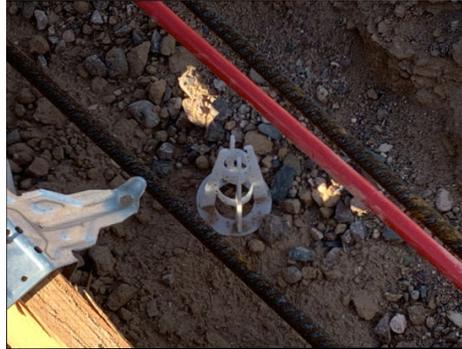
Clean all materials from trenches

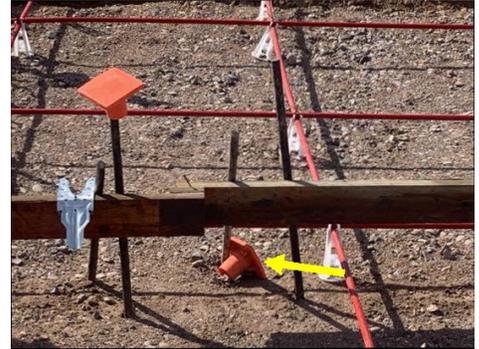
Several safety caps not installed at form stakes
