# PROPERTY INSPECTION REPORT

Date of Inspection: 9/30/2020

Addr: 10420 Welcome Home Dr.,

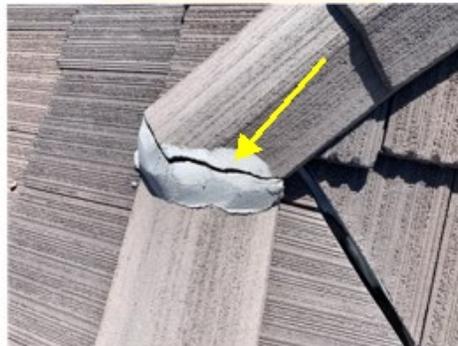
2.1. Cracking or separations noted at mortar flashings at rear roof hips.

Cracking or separations noted at mortar flashings at rear roof hip

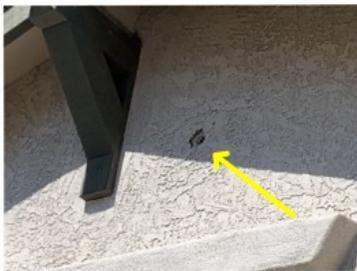
4.2. Advise stucco repairs at: Hole above front window, Small section of stucco improperly pitched at upper front roof gable vent,

Advise stucco repairs at: Hole above front window,

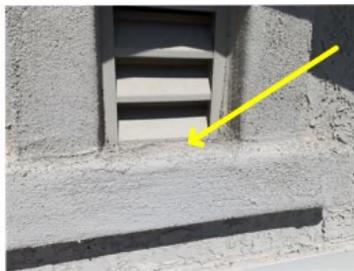
Stucco improperly pitched to pond water at upper gable vent at front roof

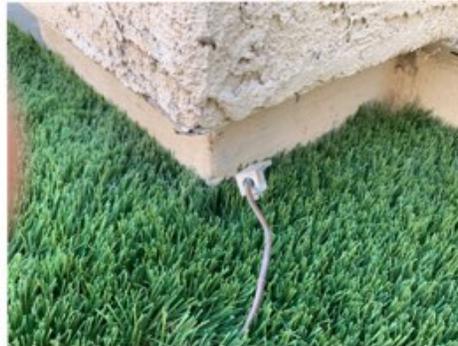
8.1. Bond wire not connected to base of stucco wall at rear patio

Bond wire not connected to base of stucco wall at rear patio

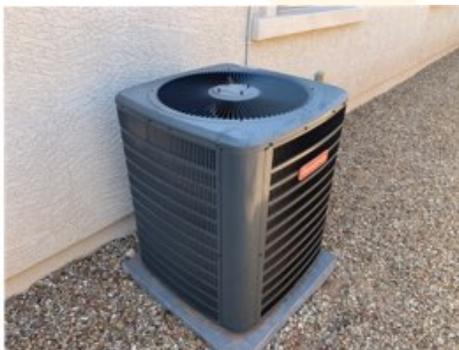
TEMPERATURES: 3 yr. old Goodman unit. Aprox. 3 1/2 tons. • Temperature differentials=18 degrees (16-22 degrees is typical) • The **A/C** unit tested acceptably.

A/C Condensing Unit

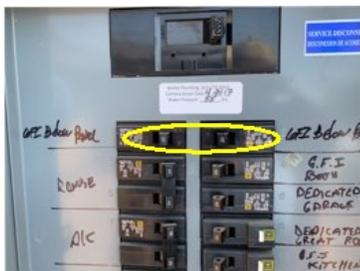
1.2. Two upper 20 amp circuit breakers were tripped. Reset OK. For outlets below panel.

Two upper 20 amp circuit breakers were tripped. Reset OK. For outlets below panel.

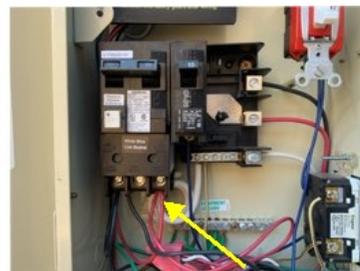
1.3. Wiring improperly doubled on breaker at pool subpanel. Advise further review by qualified electrical contractor.

Wiring improperly doubled at pool sub panel

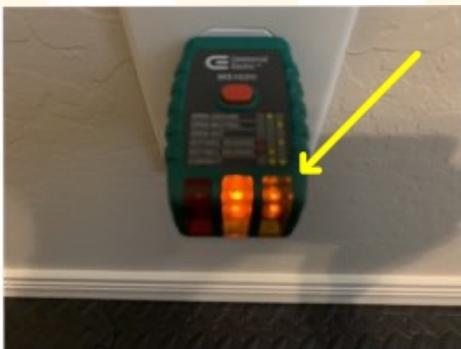
- 2.1. The outlet is loose at Center of West counter at kitchen,
- 2.2. Outlets have a weak ground connection. Noted at center east bedroom and portion of East den. Advise further review and repair.

Outlets have a weak ground connection. Noted at center east bedroom and portion of East den. Advise further review and repair.

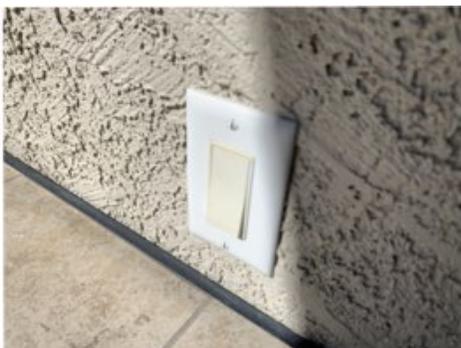
- 3.1. Advise proper exterior cover plate at fireplace switch at rear patio

Advise proper exterior cover plate at fireplace switch at rear patio
