# The Uniform Building Inspection Report™

14841 N. Black Canyon Highway, Phoenix, AZ 85023

Norte Academy

110411A

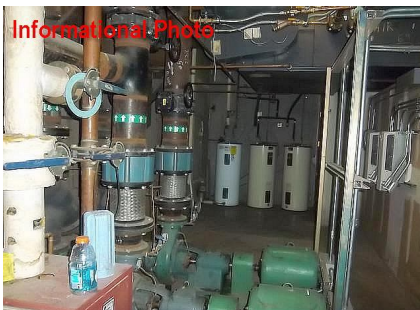
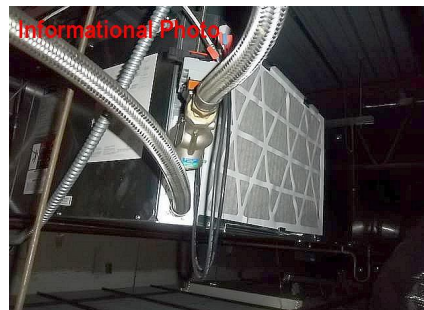
Photo: 2820 (1)

See series 2820 photo(s)
